GULFCO MARINE MAINTENANCE FREEPORT, BRAZORIA COUNTY, TEXAS

LATERAL EXTENT OF 1,1-DCE **CONCENTRATIONS IN ZONE A JULY 2006 THROUGH JUNE 2008**

LATERAL EXTENT OF 1,2,3-TCP CONCENTRATIONS IN ZONE A **JULY 2006 THROUGH JUNE 2008**

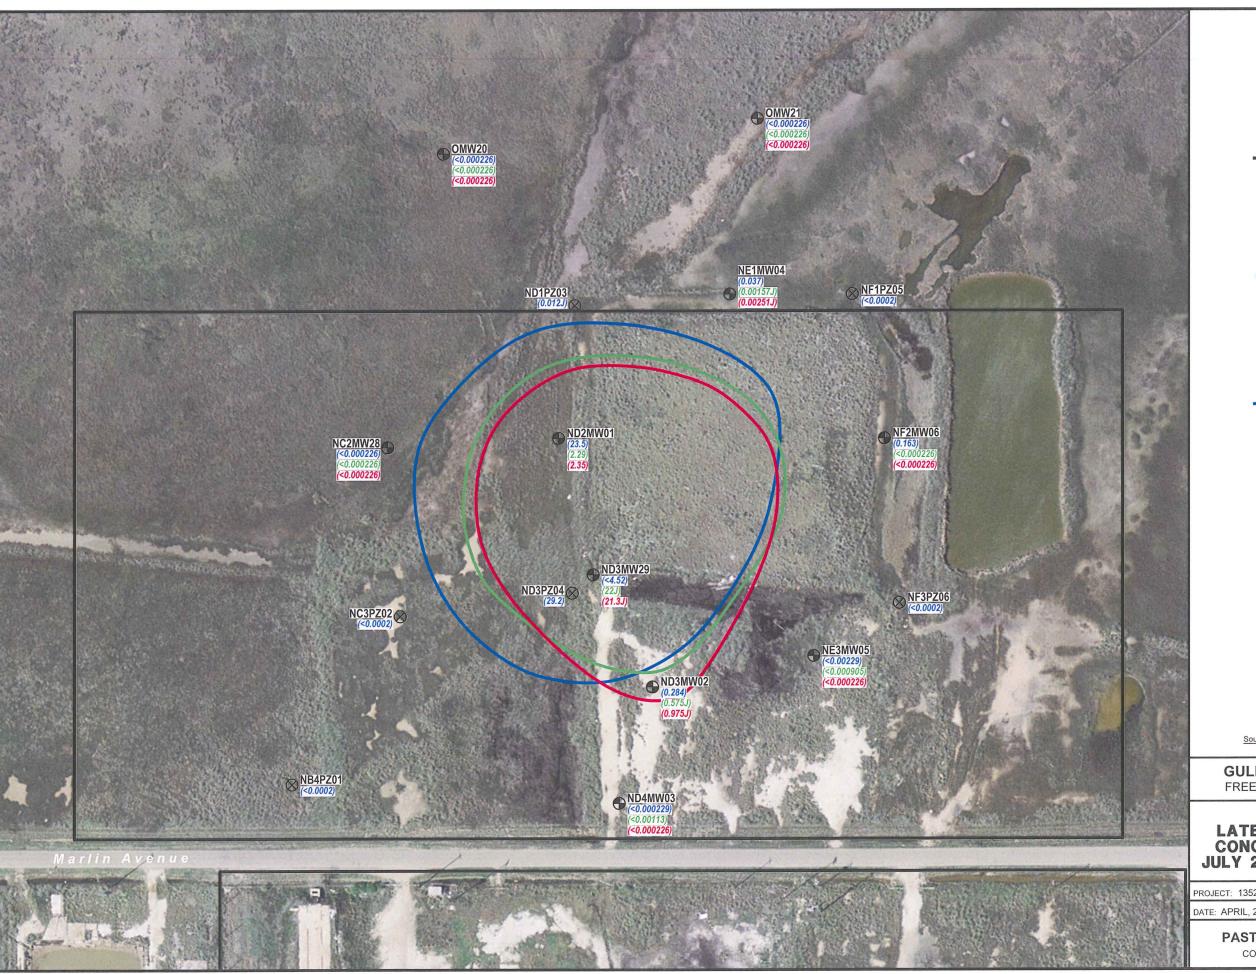
Figure 66

(0.037) 1,1-Dichloroethene (1,1-DCE) Concentration (mg/L) (Blue value for initial sample collected at each location (July 2006 - June 2007) Green value for samples collected November 2007 Red value for samples collected June 2008)

> Lateral Extent (defined by 0.7 mg/L concentration contour) Blue (July 2006 - June 2007) Green (November 2007) Red (June 2008)

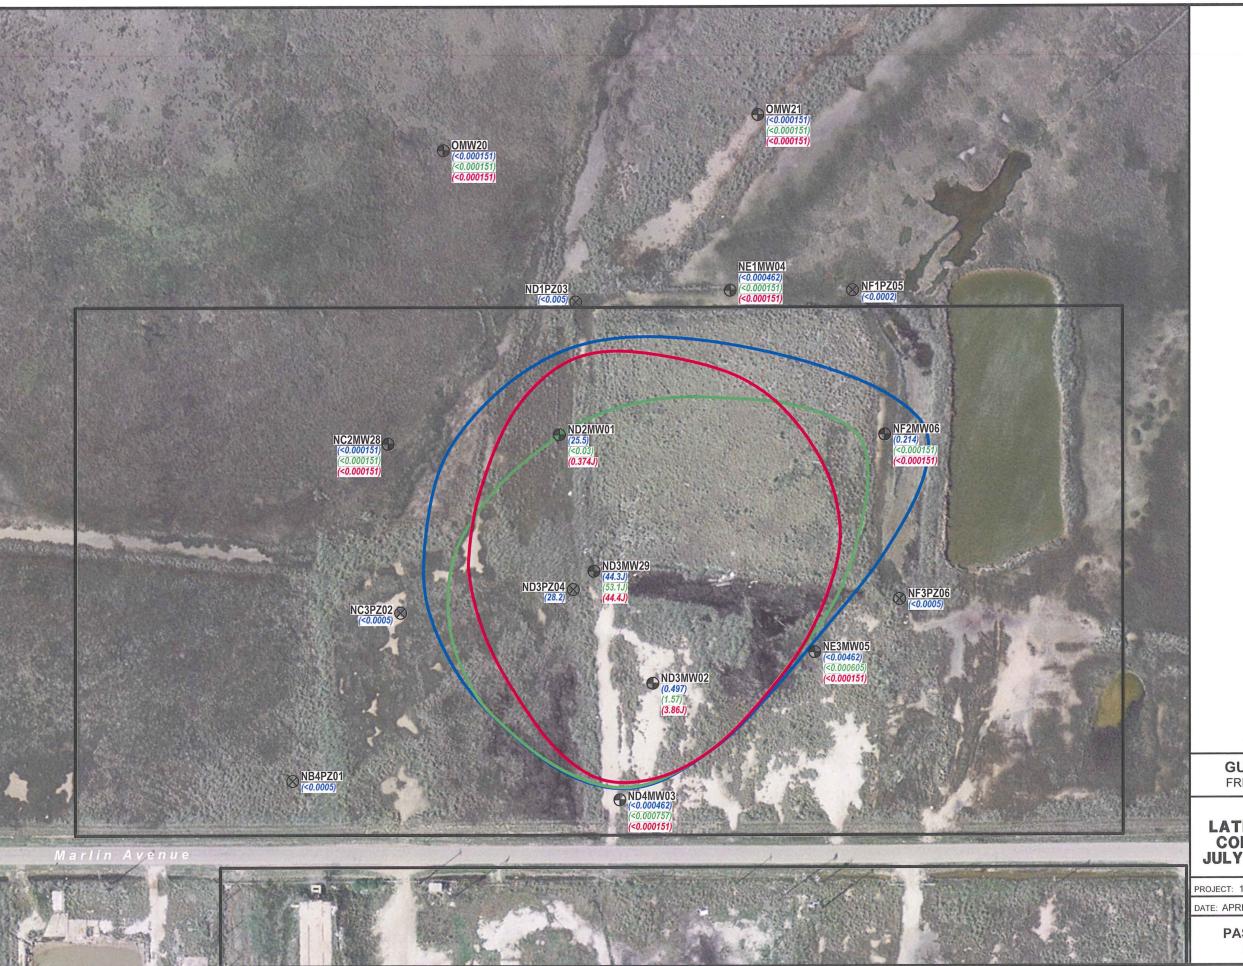
Figure 67

(0.214) 1,2,3-Trichloropropane (1,2,3-TCP) Concentration (mg/L) (Blue value for initial sample collected at each location (July 2006 - June 2007) Green value for samples collected November 2007 Red value for samples collected June 2008)

> Lateral Extent (defined by 0.029 mg/L concentration contour) Blue (July 2006 - June 2007) Green (November 2007) Red (June 2008)
